JMS578固件分位更新 (适用3139U3、6139U3、7688U3、MD35U3)

JMS578_Firmware Update_ (For 3139U3、6139U3、7688U3、MD35U3)

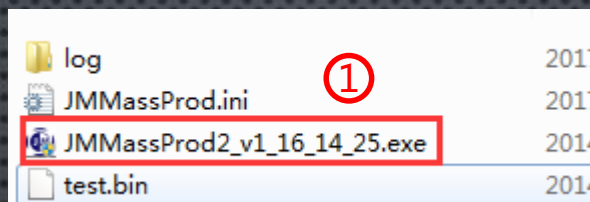
步骤一：打开“Tool”文件夹，运行“JMMassProd2_v1_16_14_25.exe”程序。

Step 1, Open the "Tool" folder and run the " JMMassProd2_v1_16_14_25.exe " program.

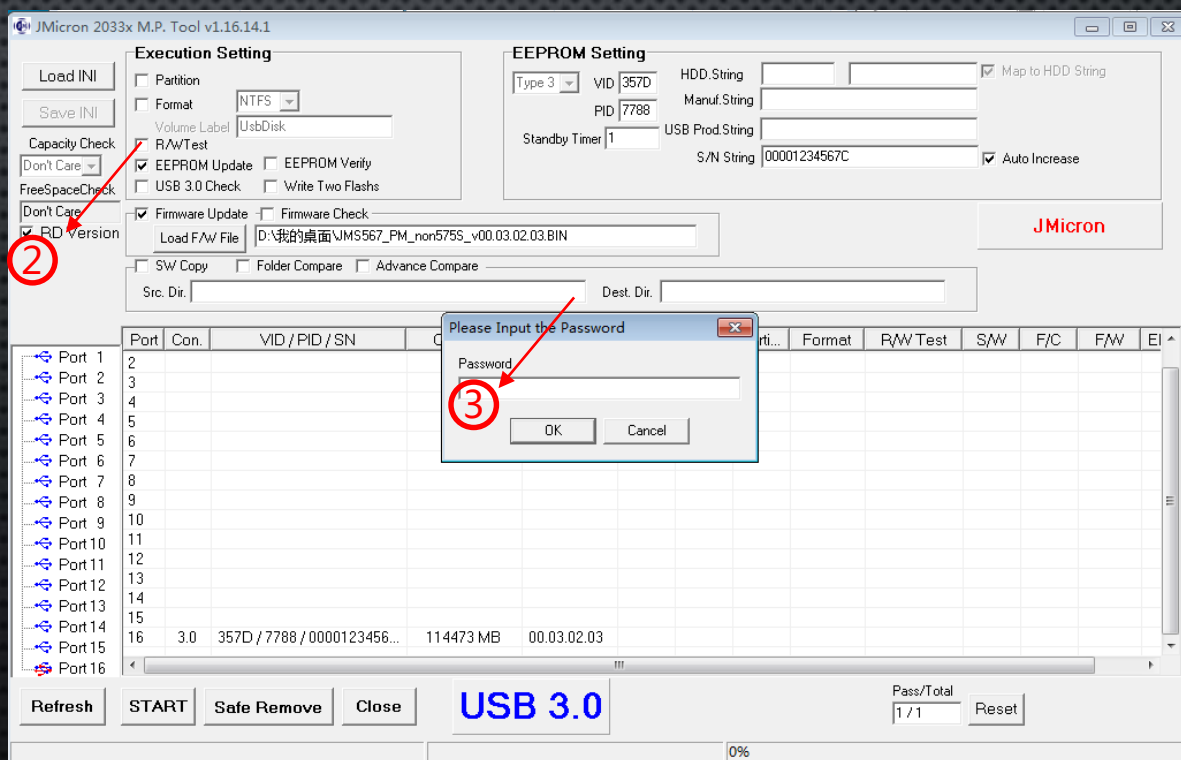
步骤二：勾选上“RD Version”。

Step 2, Check the "RD Version"

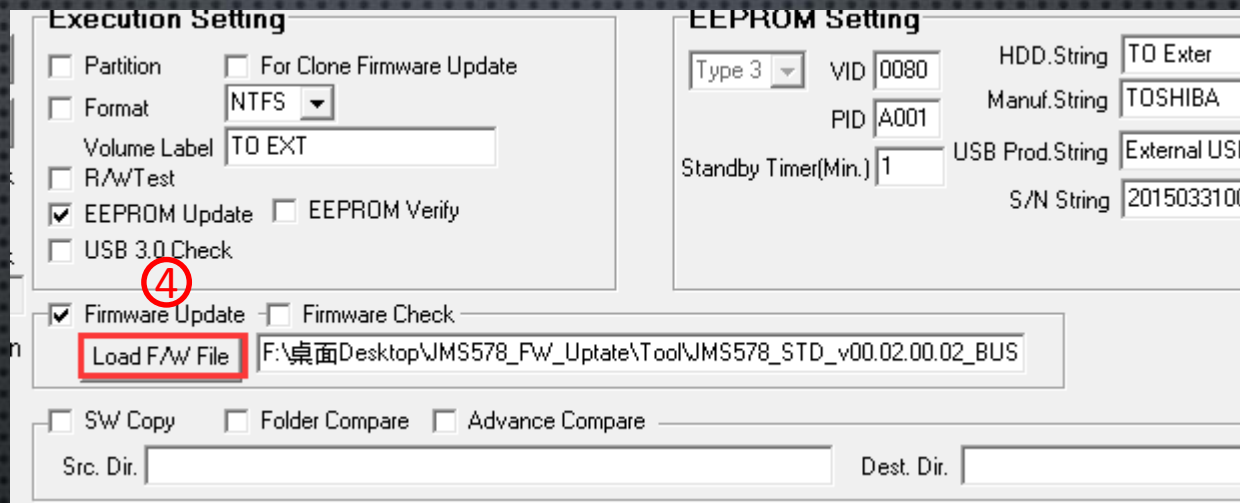
步骤四：点击 “Load F/W File” 加载固件。

Step 4, Click "Load F / W File" to load the firmware file.

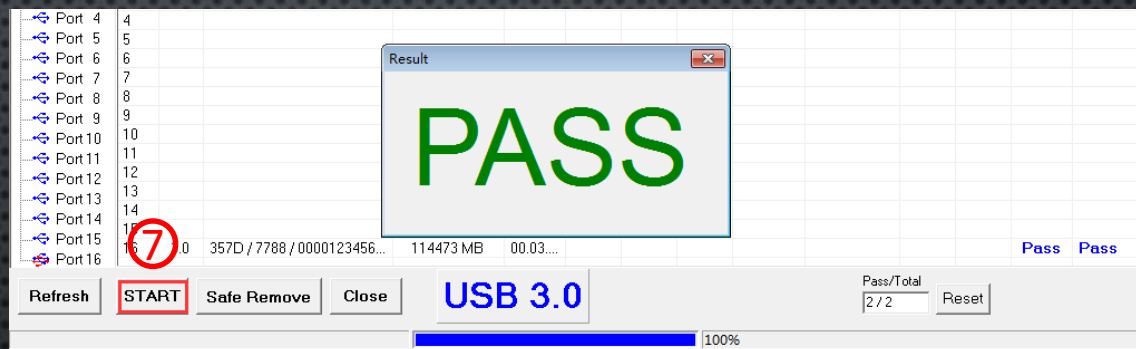
步骤六：点击 “START” 开始刷新固件，提示PASS，表示刷新固件成功。

Step 6, Click “START” to start refreshing the firmware, suggesting that PASS, that refresh the firmware success.
